**ATTACHMENT C:**

**2013 Galvin Preservation Associates Evaluation**

**180 SOUTH EUCLID AVENUE  
PASADENA, CALIFORNIA**

Historic Resource Report

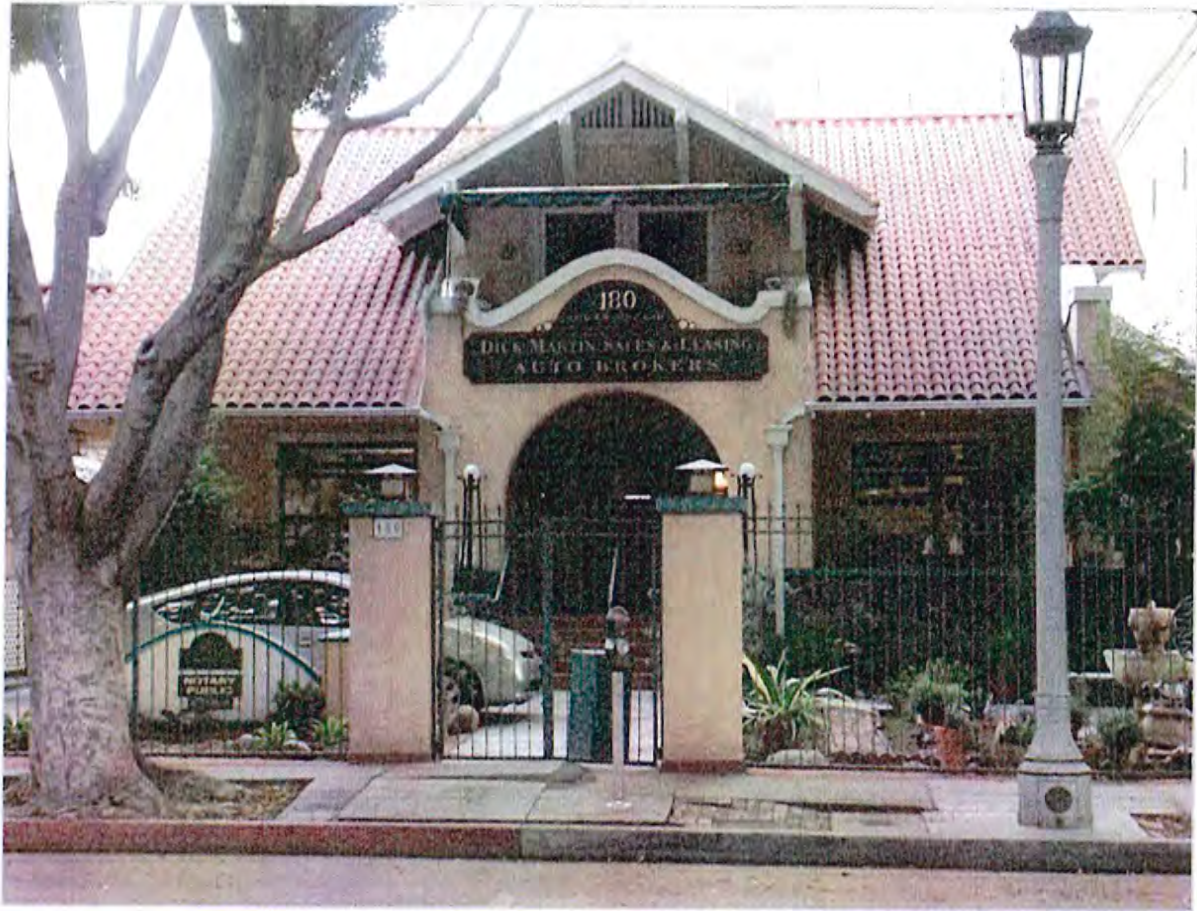
Figure 2: West Elevation. Source: GPA, November 2013.

The primary roof is side-gabled and clad with non-original metal tiles fashioned to look like clay tiles. It features decorative brackets and exposed rafter tails. The façade composition is nearly symmetrical with the exception of an offset portion of the side-gabled roof. The bottom part of the gable shifts north to form a porte cochere at the north end and cutout at the south end. Both the porte cochere and the cutout terminate at wing walls with shaped parapets oriented perpendicular to the street. Each wing wall features an arched opening. The arch on the south wing wall originally led to a trellised porch. The trellis has since been removed.

The building is accessed via a set of tiled steps leading to a recessed full-width entry porch on the west elevation. The center of the elevation features a balcony within a front-gabled dormer at the half story over the porch. The balcony is enclosed by a square bay, which projects from ground level up through the gable eave. The west-facing wall of the bay is identical to the wing walls: it has a large arched opening at the porch level and a shaped parapet at the half story, which functions as the balcony railing. The archway leads to the main entrance, which consists of a single wood door. The door has a single arched light, decorative paneling, and antique hardware. It is flanked by what appear to be single-light wood windows and set within a wood surround (see Figure 6).

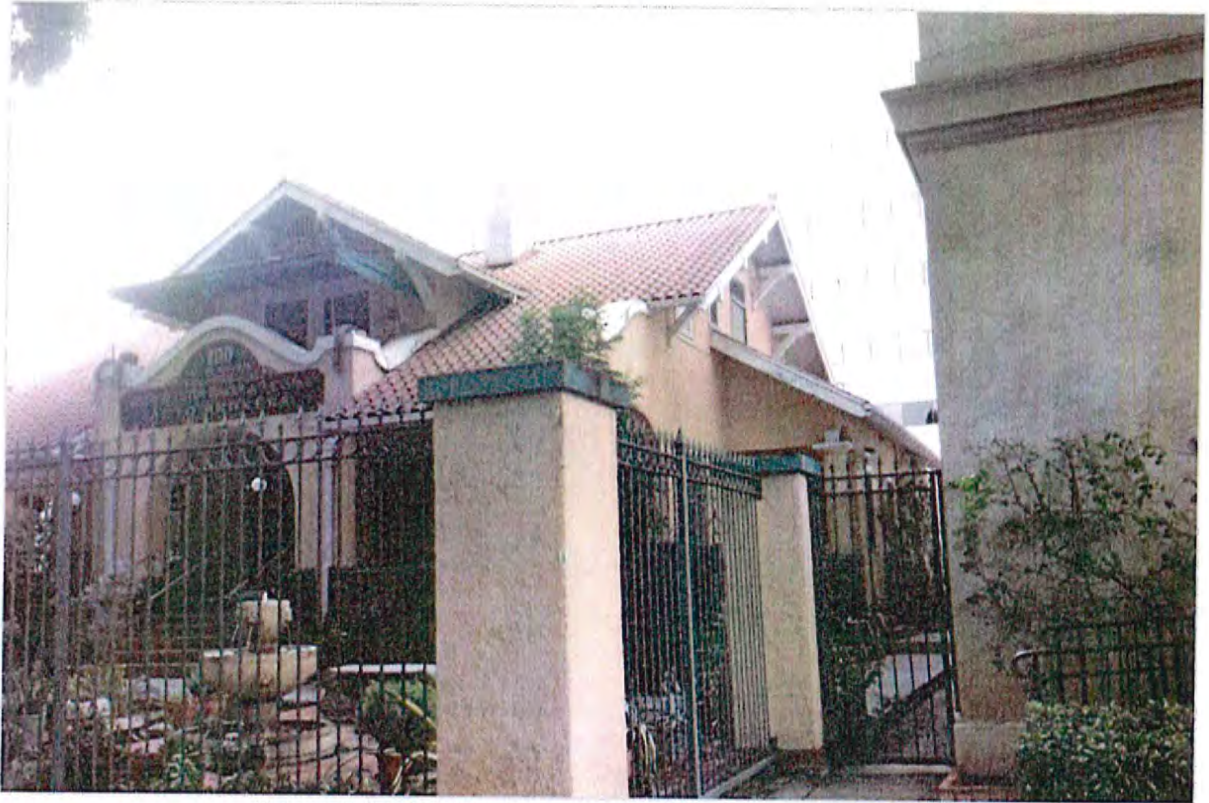
Figure 4: South Elevation. Source: GPA, November 2013.

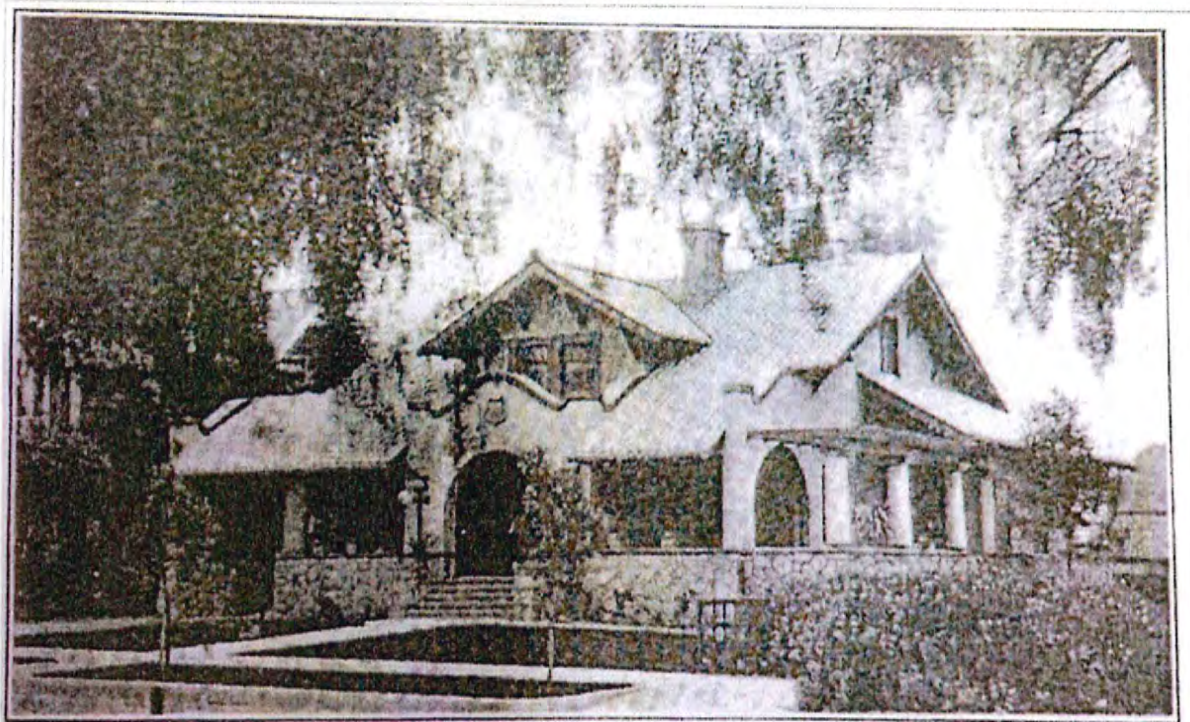
Figure 5: Historic Photograph from *The Architect and Engineer*.

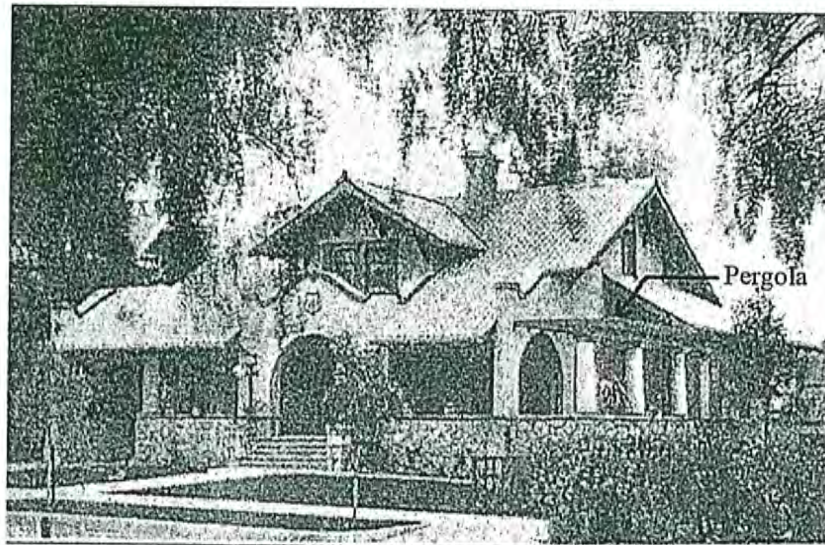
*Residence of Mr. R. H. Penney, Pasadena  
C. W. Buchanan, Architect*

From review of the historic photograph found in the *Architect and Engineer of California*, dated February 1908, a wooden pergola structure was located at the southwest area of the building, supported by three Doric columns. This character-defining feature has since been removed (Figures 5 and 6).

**Figure 5.** Historic photograph from source: *The Architect and Engineer of California*, February 1908. Looking northeast; note the original character-defining pergola design feature.

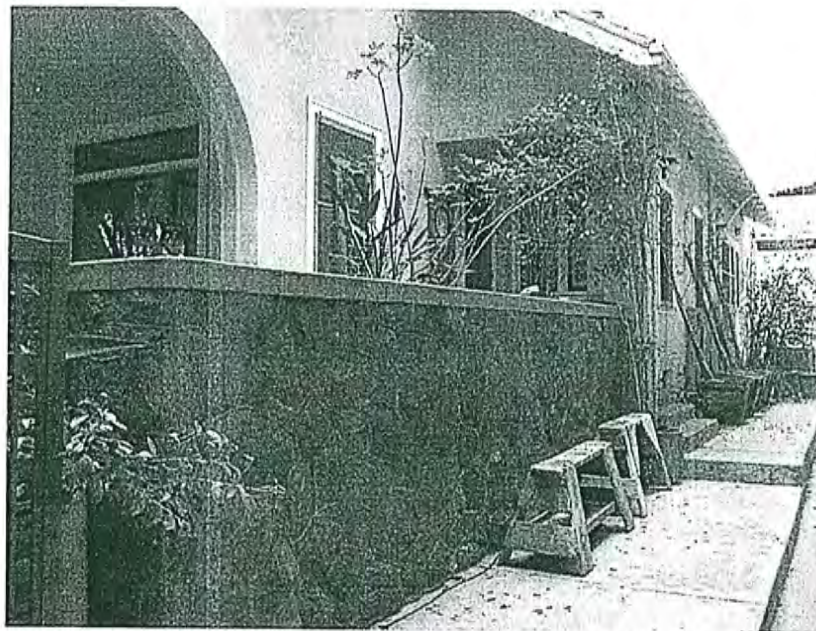
**Figure 6.** Looking northeast at the quartz stone wall, located at the southwest corner of the building. Note the missing Doric columns and wooden pergola structure.

- **Design** – The building's original architectural design, by architect C.W. Buchanan, has changed by first the removal of the character-defining pergola wooden structure supported with Doric columns, located on the primary street front elevation. Second, two window openings have been altered and re-sized for two door openings. Third, the substantial 1992 and 1994 alteration of the rear east elevation with the addition of a stairway and upper deck with roof structure has changed the building's exterior spatial relationship. It is evident, by review of the Sanborn maps dating back from 1910 to 1951, that the U-shaped floor plan was intended by the architect to be used as an open courtyard space relating to the backyard; which most likely was landscaped with vegetation. Fourth, the interior has been drastically changed by the removal of single-family amenities and rooms on the first floor to accommodate a commercial office use; resulting in a complete change in the spatial relationship with the original residential floor plan design. Last, the second story has also undergone modern interior alterations to accommodate a separate living

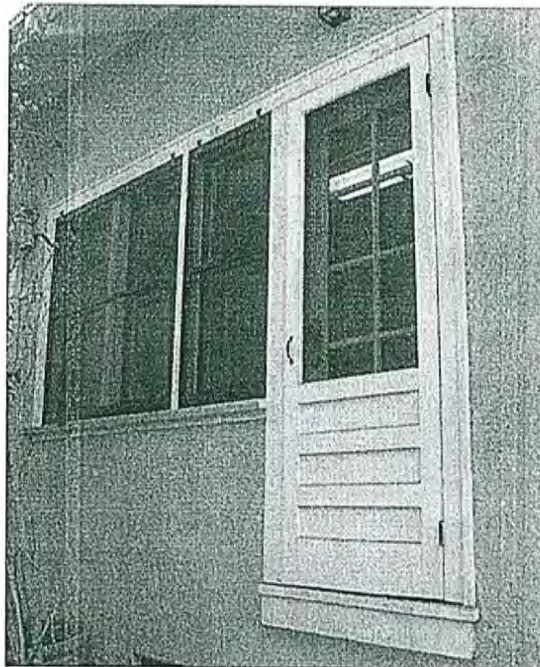
Two windows have been replaced, one located on the south elevation, and the other within the upper story's south elevation, by resizing the window opening for two door openings (Figures 8 and 9).

**Figure 8.** Looking northwest, south elevation, at a window opening resized for door opening; 1994 permit.

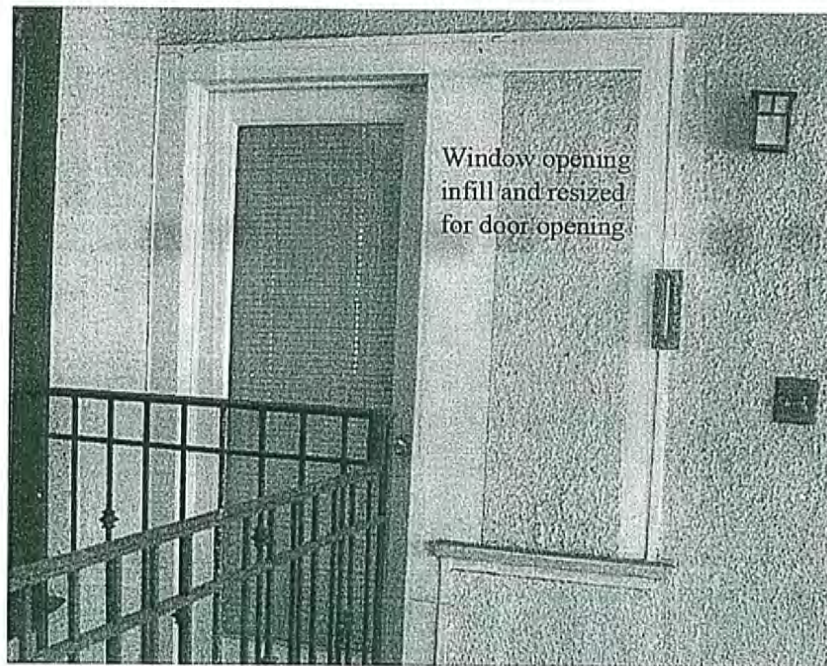
**Figure 9.** Looking north, south elevation of rear upper story, window opening infill and resized for door opening; 1994 alteration permit.

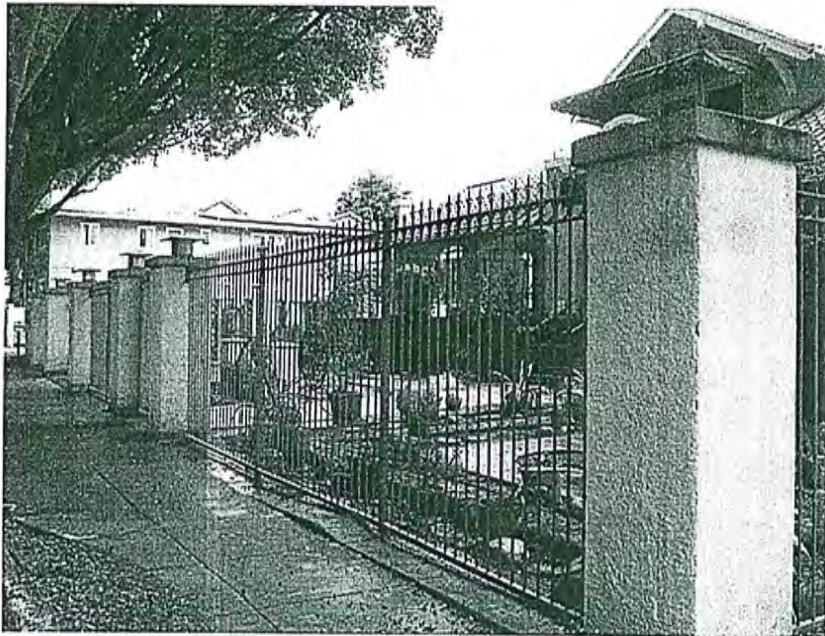
The front porch floor and steps have been altered and replaced with Mexican tile porch pavers (Figure 10). In addition, the open front yard has been changed by the introduction of six large square piers with iron fences and security gates (Figure 11). The interior yard consists of paved concrete, Mexican tile pavers, red brick, and two small square piers with an arched commercial business sign (Figure 12).

**Figure 11.** Looking northeast along the front yard area and sidewalk with six large piers and iron security fence.

- **Setting** – The property's front yard was originally an open lawn area and it has changed substantially by the replacement of the original landscaping with concrete paving, Mexican tile porch pavers, and six large square piers with iron security perimeter fences. To the rear (east end) of the building, the yard has been paved over with asphalt paving. Furthermore, the surrounding street context area has changed from a residential neighborhood to a modern commercial and apartment building setting. There appears to be no potential for a historic district in this area. Due to the alterations listed above, this property has lost integrity under the aspect of setting.

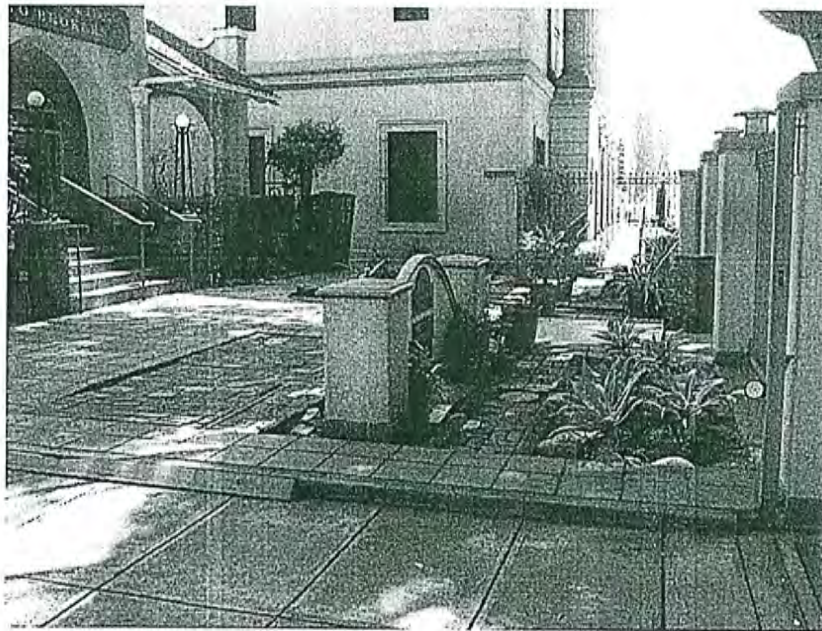
**Figure 12.** Looking south at the front yard area with modern Mexican tile porch pavers, concrete paving, red brick, and square piers with sign.

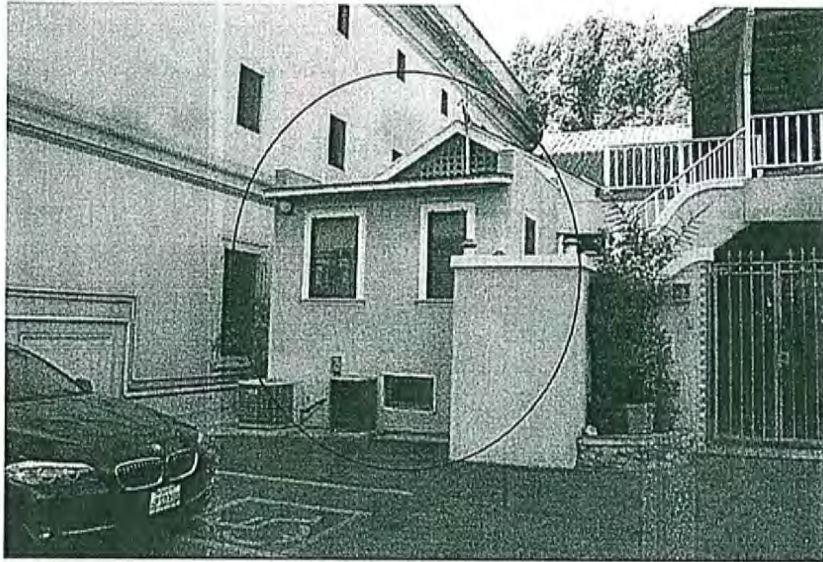
The rear of the house has been substantially altered by an addition to the southeast corner of the building circa 1910-1931 (Figure 13) and the addition of a stairway and upper deck with roof structure constructed in 1992 and 1994 (Figure 14). As architect C.W. Buchanan designed the residential house consisting of a

**Figure 13.** Looking southwest at the addition to the southeast corner of building.

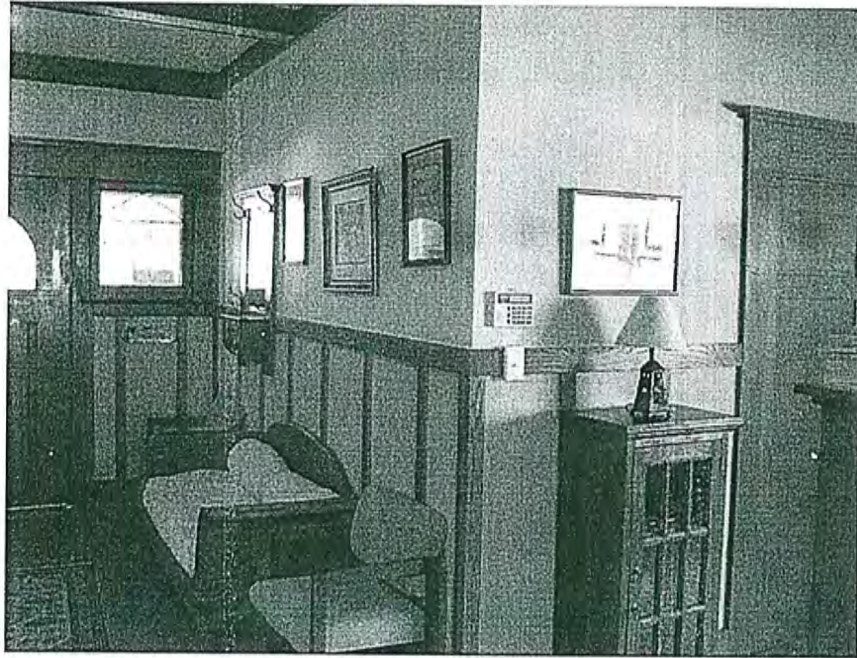
From a site visit on September 15, 2015, Architectural Historian Steven Treffers observed that nearly all the interior rooms and walls on the first floor have been removed and reconfigured to accommodate a commercial office use. This alteration has changed the spatial relationship of the interior spaces in that it no longer corresponds with the original architect's residential floor plan design (Figures 16 and 17). Further, a kitchen at the northeast portion of the building has been substantially altered and reconfigured through the addition of new interior walls (Figure 18)

**Figure 16.** Looking northwest at the added enclosed office room at right. Fireplace is out of view directly to left.

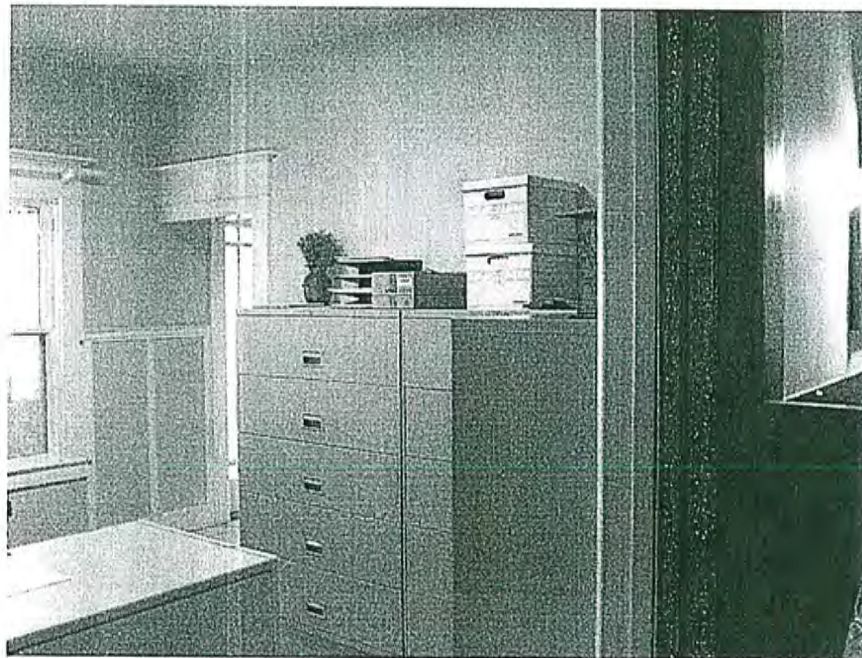
**Figure 17.** Looking northeast at an office room located to the north half of the building.

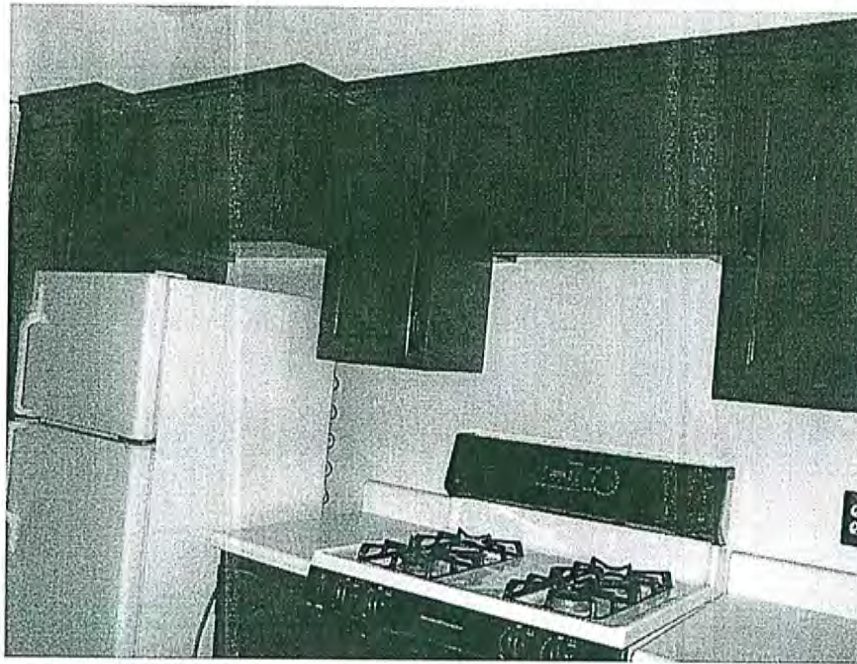
**Figure 18.** Looking northeast at the second-story kitchen area.
